The Diamond Pro Stone Cut® retaining wall system is a barrier that protects the road for the tanker trucks that make the daily commute on this steep slope to the nearby Interstate highway.

Garden Gulch Road  
PARACHUTE, COLORADO

Diamond Pro Stone Cut®  
retaining wall units

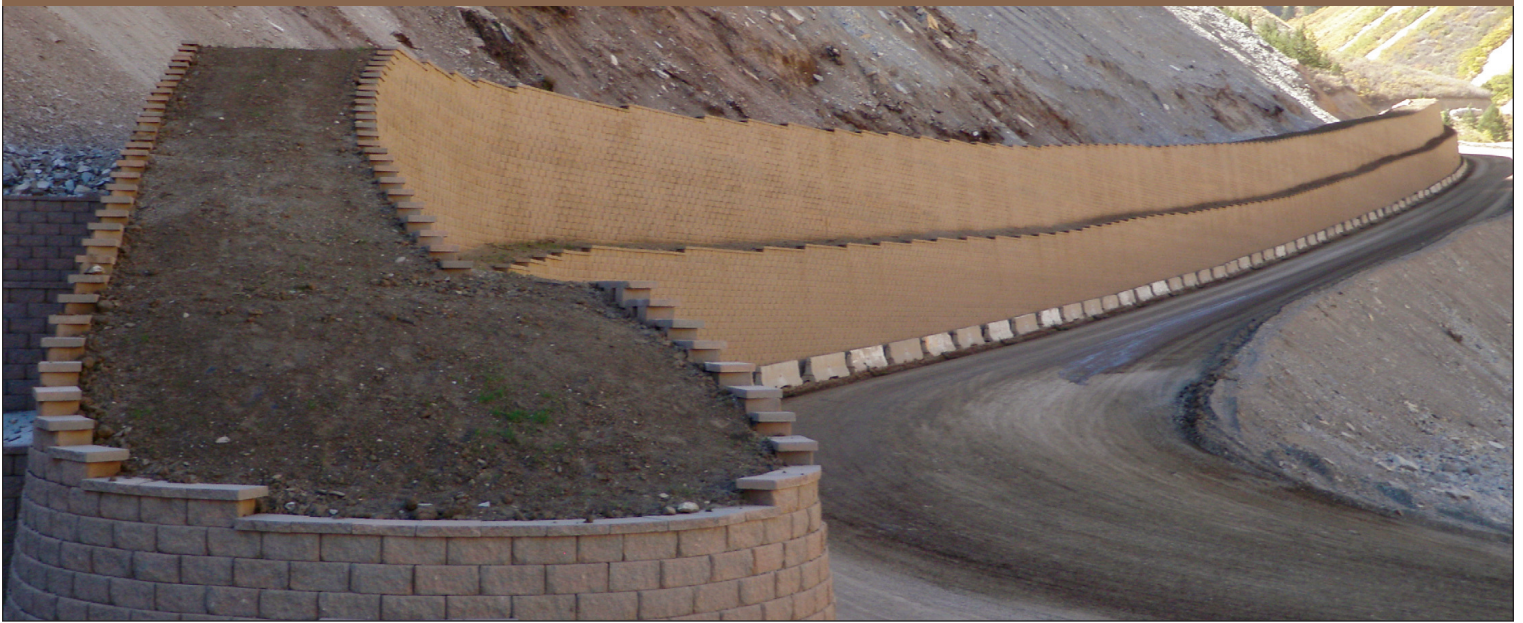
**The back-to-back Diamond Pro Stone Cut® retaining wall is a creative solution that stops falling boulders from the steep mountain onto the service road.**

A back-to-back terraced retaining wall using the Diamond Pro Stone Cut® retaining wall system was designed to function as a barrier for falling rocks and boulders.

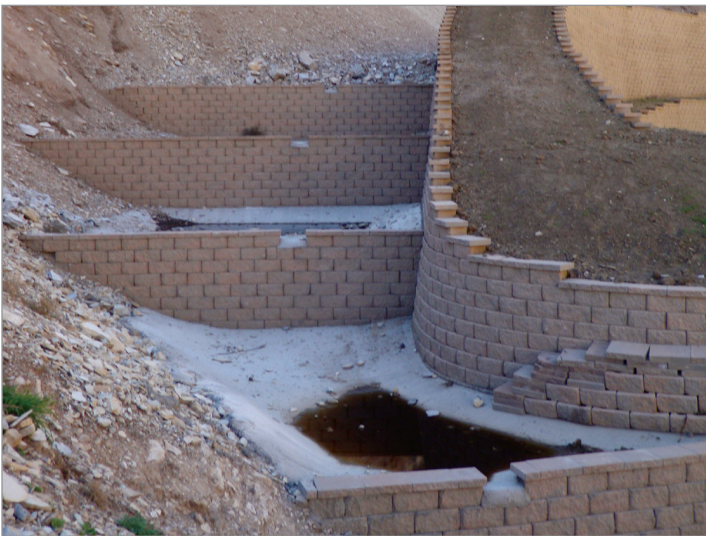
**The three-level terraced retaining wall is where falling rocks stop safely away from the road.**

The well-balanced design of the massive terraced structure stops the tumbling boulders from landing on the road. The oil company that commissioned the barrier considers it a complete success as crews can now use a short route between the mountain and the nearby Interstate highway, saving time and miles. But safer driving conditions are the ultimate success, as drivers can now focus on the job itself: negotiating hairpin curves, rugged dirt conditions and frequent blizzards.
